CR-175002  
SEPTEMBER 9, 1985  
21-5477

# THERMAL BARRIER COATING LIFE-PREDICTION MODEL DEVELOPMENT FIRST ANNUAL REPORT

FOR NASA LERC CONTRACT NAS3-23945

GARRETT TURBINE ENGINE COMPANY  
A DIVISION OF THE GARRETT CORPORATION  
PHOENIX, ARIZONA

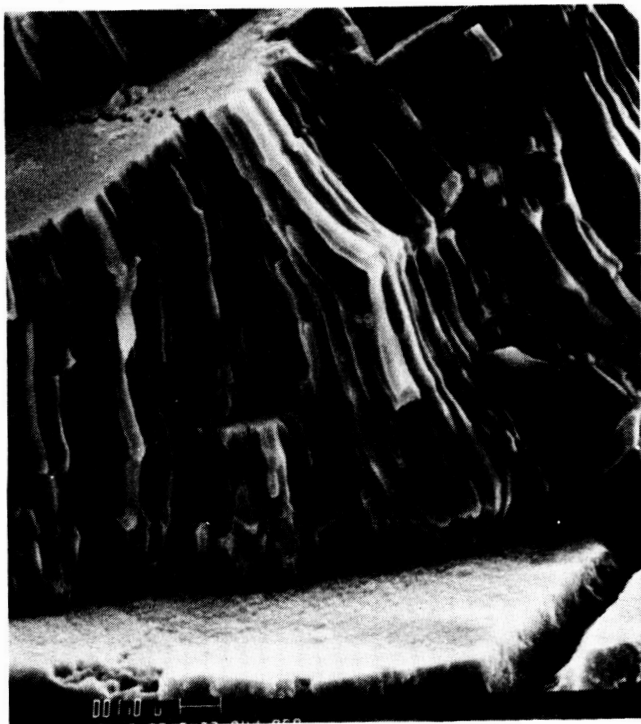
Before Thermal Cycling

After 9000 Oxidation Cycles to 1010°C

Figure 3-3. Localized Columnar Solidification Microstructure in Plasma-Sprayed Zirconia Coating (Partially Stabilized with Yttria) Becomes Microcracked During Thermal Cycling.

Microcracking is not fully developed, however, in the as-sprayed condition. As indicated in Figure 3-3, plasma-sprayed yttria partially stabilized zirconia can develop a columnar solidification structure within most of the "splattered" particle layers. Testing has indicated that thermal cycling is necessary to achieve

the majority of the subcritical microcracking of the solidification microstructure. An acoustic emission study indicated that most of the microcracking probably occurs during the initial thermal cycle(s). Once formed, the small intercolumnar gaps in this microstructure are available to accommodate imposed strains by free expansion (or contraction) of the columns into the gaps, which results in minimal stress build-up in the coating.
